# Construction in the Caymans

## What happened

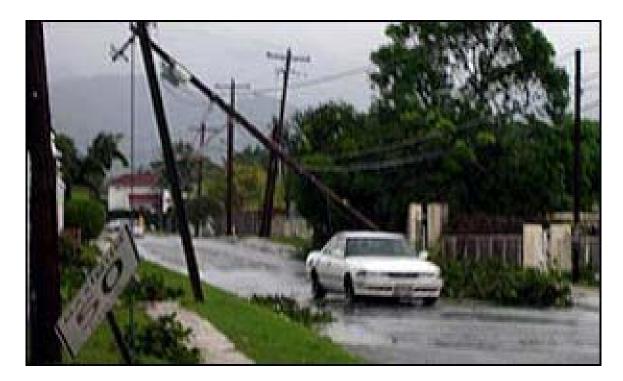
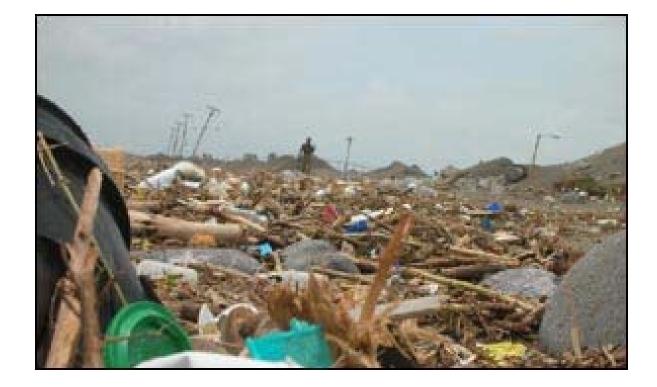
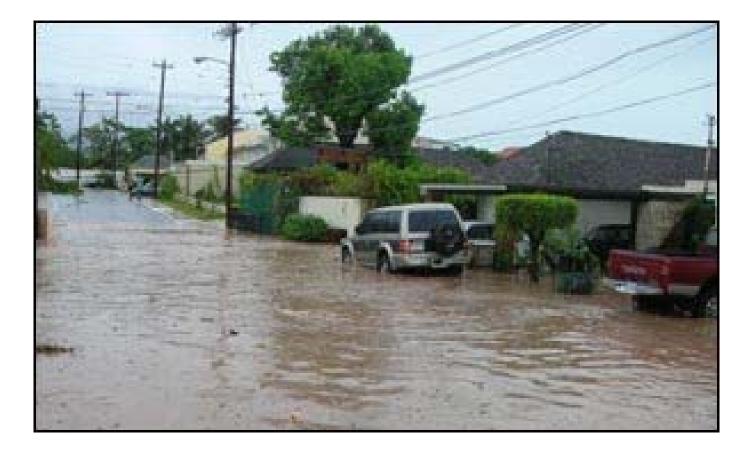
Rain and wind driven sea lashed across the island tearing apart the infrastructure and much of the island property

### All in all the Cayman Islands were a mess

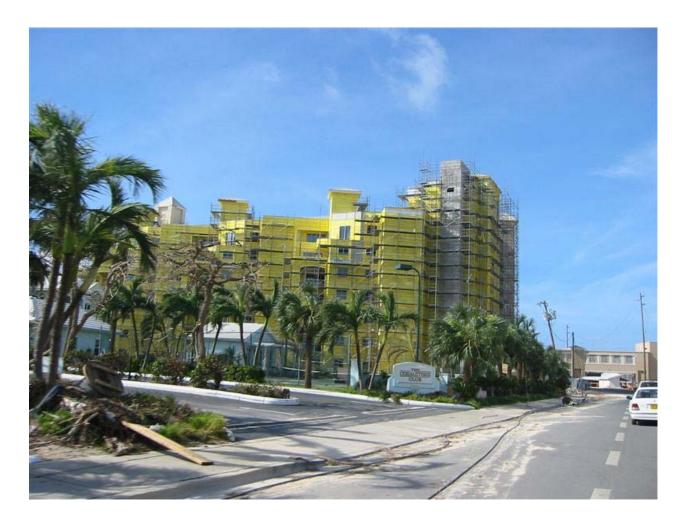
#### The hotel however didn't look too bad!!

First impressions from the adjustor implied that although a bit bent and battered the hurricane precautions had stood up well and damage although significant wasn't as bad as the rest of the island.
