**Nondestructive Examination of Turbine and
Generator Components
Experience with Mechanized Examination Techniques**

Michael Siegel*, Hans Rauschenbach*, Bruno Metzner**

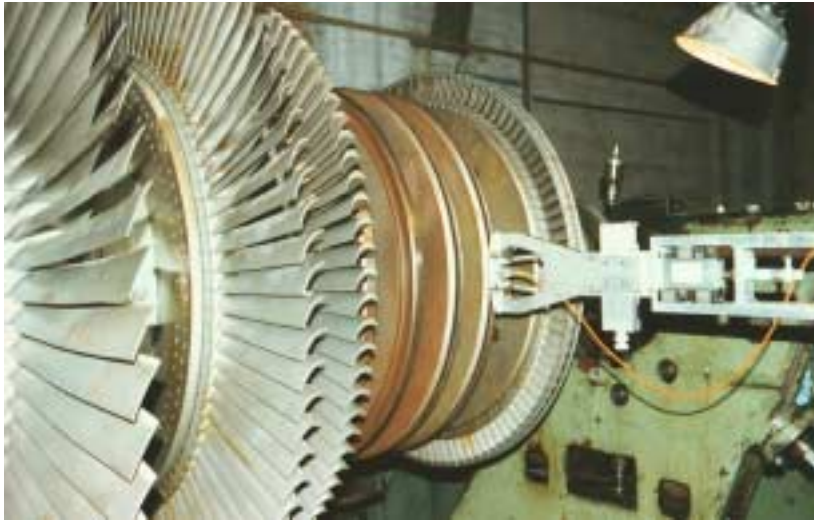
Figure 2
Mechanized ultrasonic examination on the feed pump shaft

In the first mechanized ultrasonic examination, a single indication (in accordance with SEP 1923) with a maximum reflectivity equivalent to a circular reflector approximately 10.5 mm in diameter was detected. Significant backwall echo attenuation (12 dB, search unit EL20) was observed in the area of the indication. It was not possible to determine the length of the reflector due to the shaft profile.

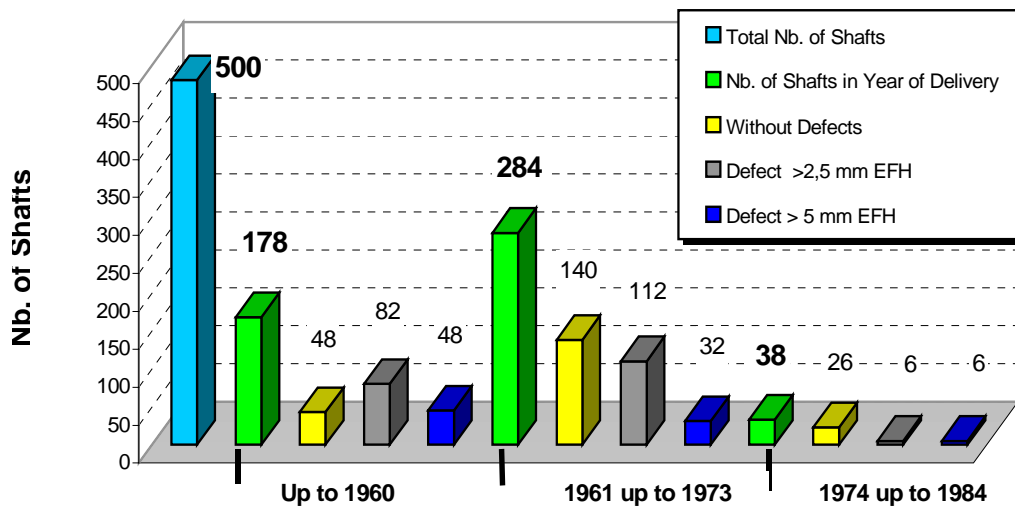
SIEMENS Power Generation Group has carried out ultrasonic examinations on turbine shafts (OEM and non-OEM) subjected to service-induced stress since 1983. The extensive experience built up as a result confirms the effectiveness of the ultrasonic requalification process. Analysis of 500 examinations performed on turbine shafts clearly shows that indications were frequently detected, particularly in older turbine shafts. For example, of 178 turbine shafts manufactured before 1960, indications equivalent to a circular reflector size > 5 mm in diameter were found in 48 turbine shafts (27% of the examined shafts), with 3% even exhibiting flaws equivalent to a circular reflector size up to approximately 18 mm in diameter. A further 48 turbine shafts showed indications equivalent to a circular reflector size > 2.5 mm in diameter.

Figure 14 Analysis of examination results as a function of year of delivery of turbine shafts

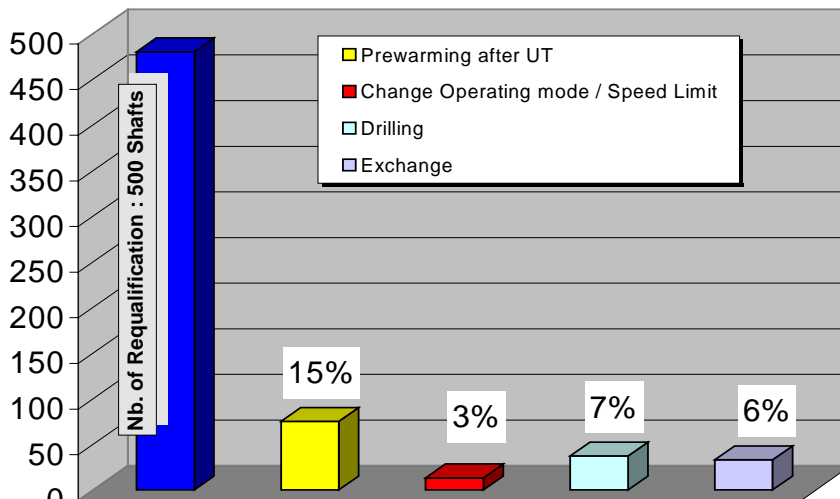
Figure 15 Analysis of actions taken after performance of ultrasonic examinations

After UT-requalification, 15% of shafts had to be prewarmed to allow further operation. In the case of 3% of shafts, instructions were given with regard to operational measures. In 7% of shafts, the findings were eliminated by drilling or enlarging the existing bore. Finally, for 6%, i.e. 30 shafts, replacement was recommended.
