## Launching of a long span viaduct

## Characteristics of the viaduct

- Length : 590 m
- Spans : 85 + 140 + 140 + 140 + 85
- Structure : lattice girder
- Piles height : 60 m
- Placing : by launch
- Value : EUR 22 m

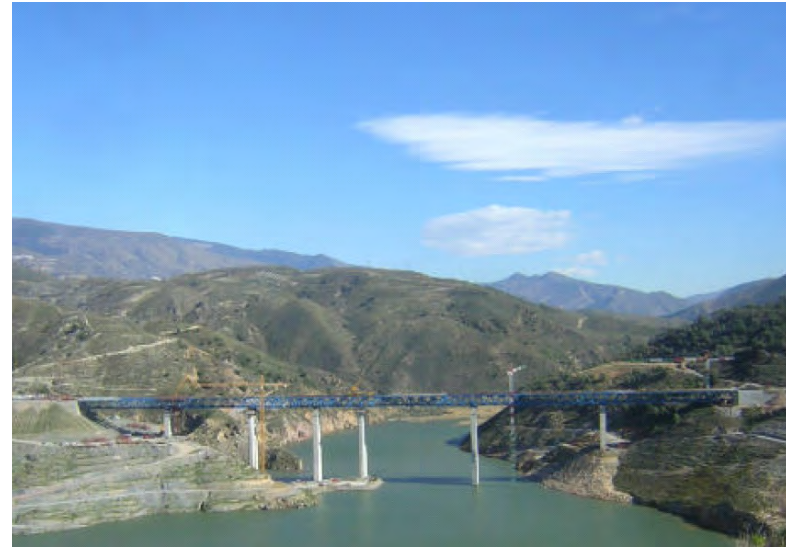
- The launch was carried out with the temporary support of a steel truss tower and a group of 8 post-tensioned cables.
- During the launch through the 4<sup>th</sup> span the girder suffered a sudden large plastic deformation.

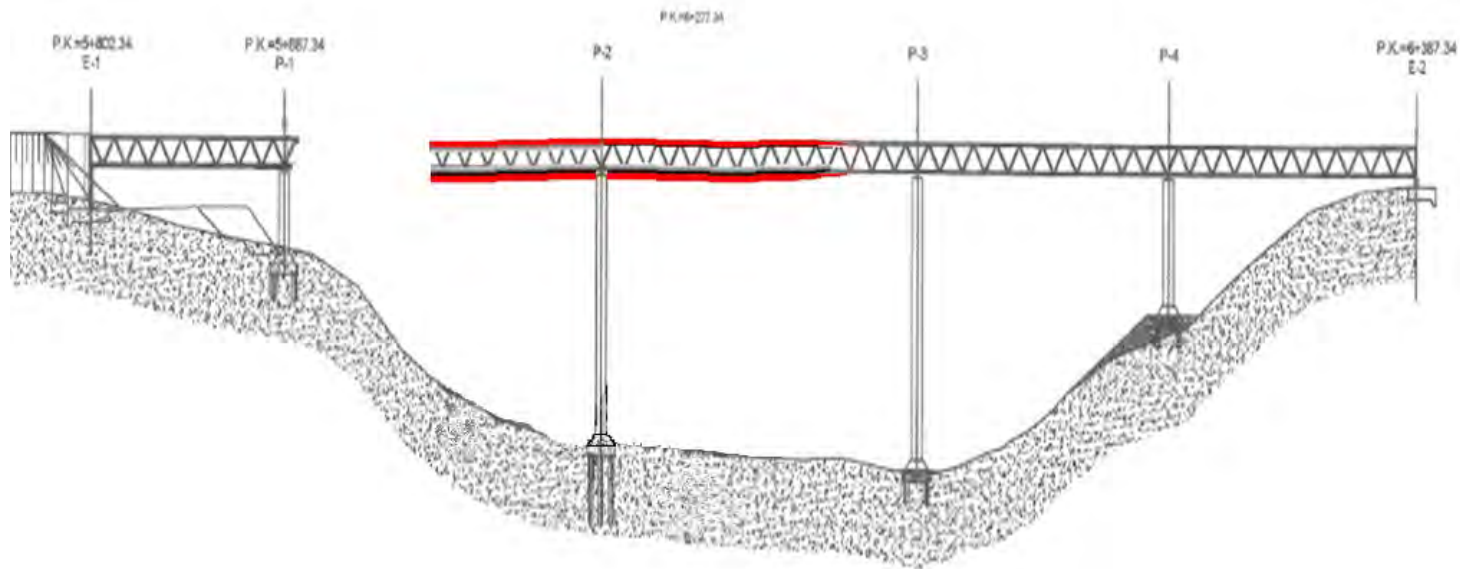
The reparation process was complicated by the size of the girder and its position over the reservoir.

The sequence finally decided was the following:

1. Lowering of the level of the reservoir and construction of a reclaimed platform.
