Short paper on an interesting case of damage

Supplied by Generali Versicherung, Austria (June 2009)

Erection of a thermal waste utilisation plant

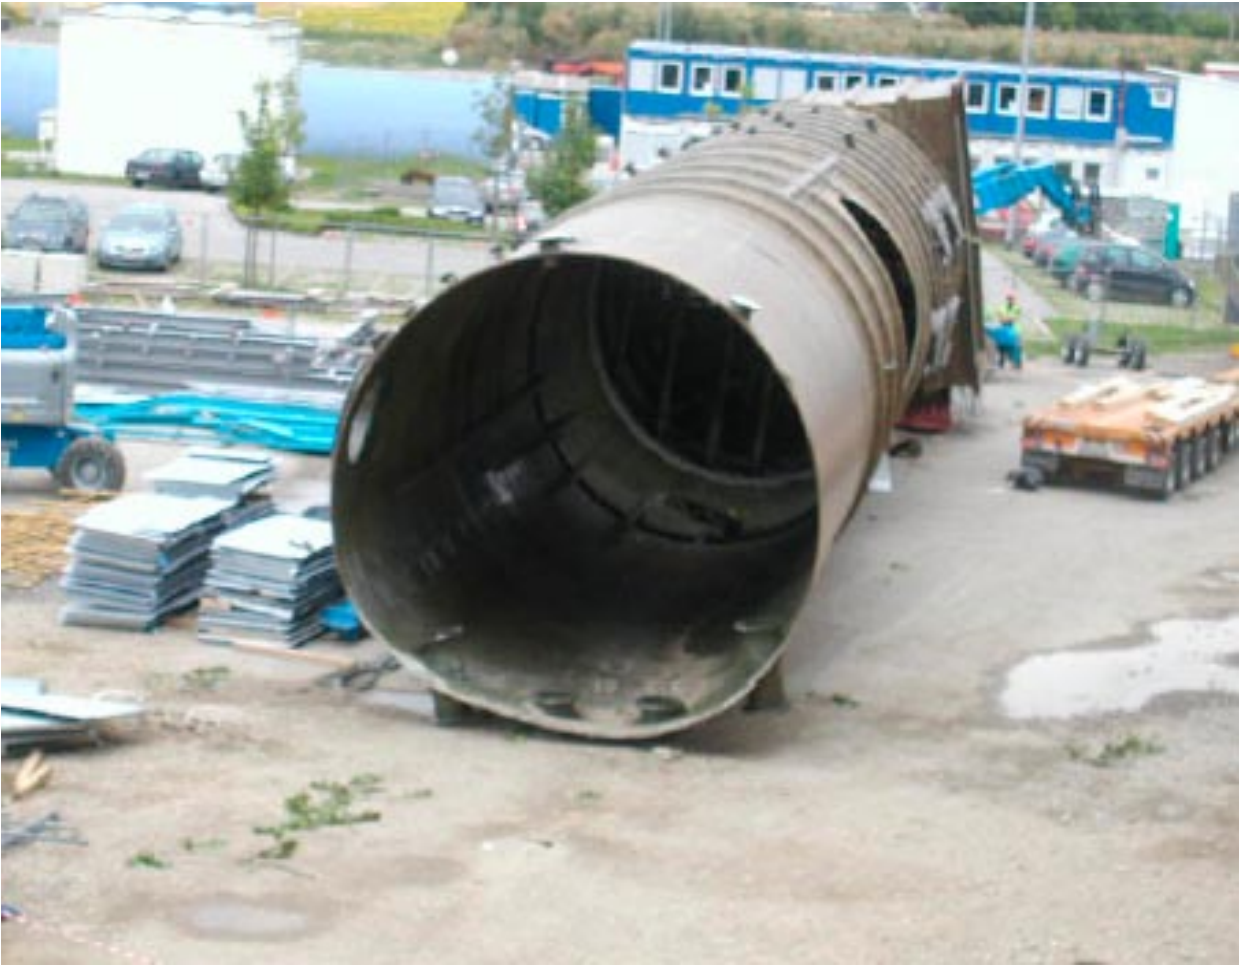
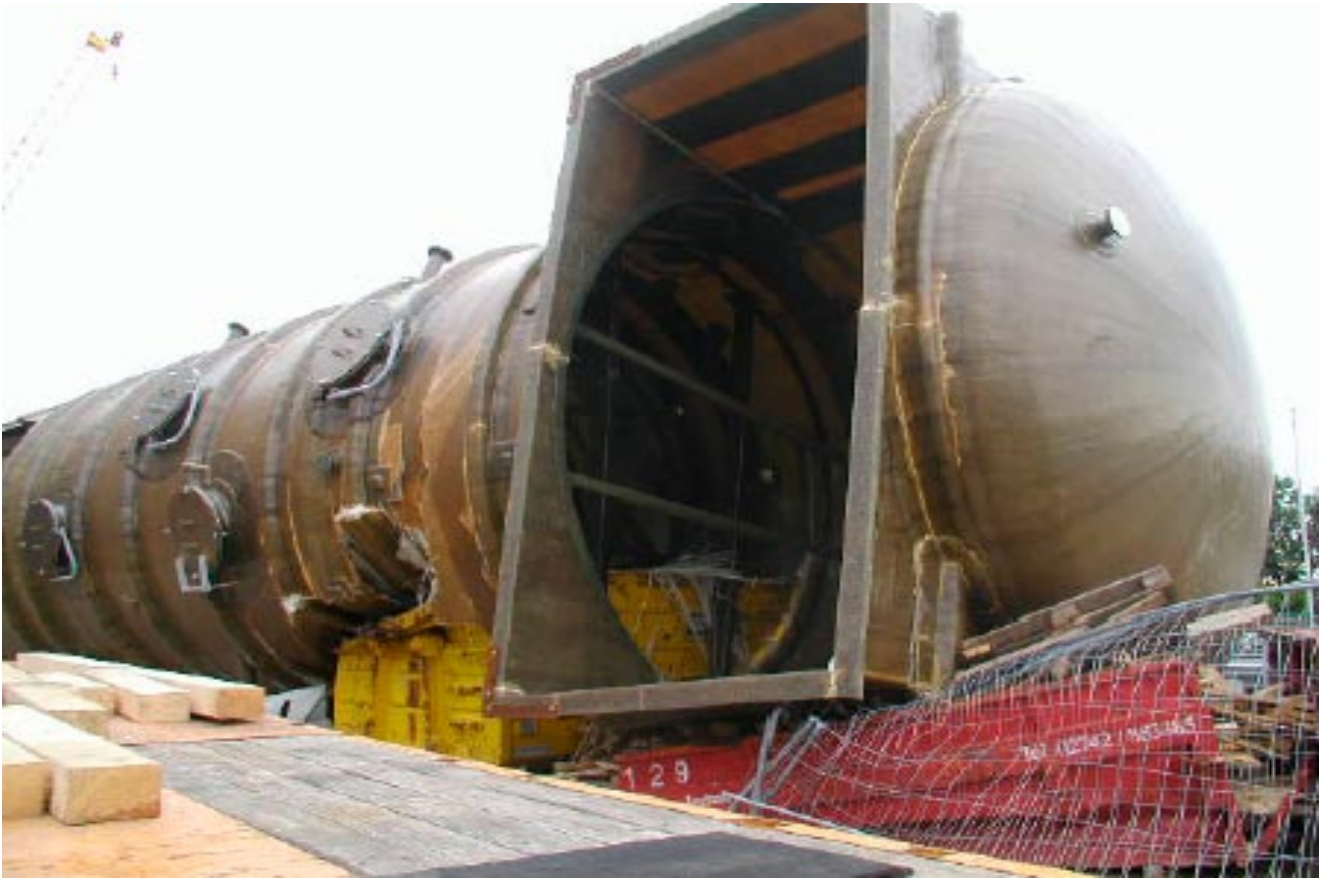
Damage occurred to a large flue gas scrubber. At first, two cranes lifted the scrubber and propped it up. After the scrubber was standing upright, the supporting crane was detached. The scrubber was lifted for positioning by the main crane up to an altitude of 4.5m above the floor. While performing this action, an ear of the scrubber for attachment of the ropes broke off. As a result, the other ears were overloaded and went off as well. The scrubber fell down and toppled over, destroying a container and further steel construction works.

Damage of vessel and container

Several specialists were contacted. An expert's report was done. It was then decided to repair the parts on site, except for the head section of the scrubber. This part was ordered in Taiwan to be remanufactured supplied. Total expenses for the repair and the new fabrication amounted to EUR 620,000.
