**IMIA.  
Wind Turbine Generators.**

**Claims.**

**Codan Insurance / September 2007  
Risk Engineer Truels Kjer**

**Claims involving the main components of the turbine.**

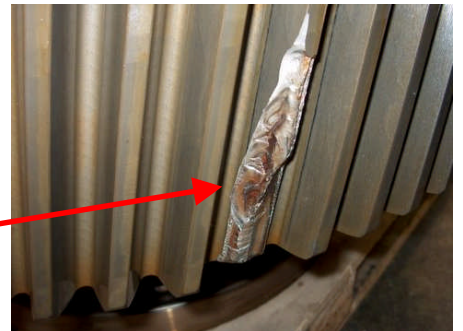
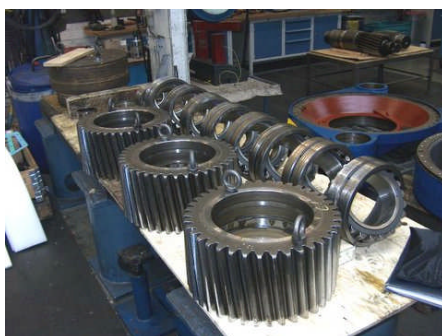
*Root causes.* Never concluded. It has been a general problem for many years independent of the manufacturer.

*Damaged parts.* All parts of the gearbox. Bearings, shafts and gear mesh both in the planetary and the helical stage. Though pitting/wear of the bearings in the planetary stage are most common.

The three wheels and the 6 bearings from the planetary stage of a typical gearbox.
