# UNPREDICTABLE GROUND CONDITIONS AND FORESEEABLE LOSSES IN **CONSTRUCTION ENGINEERING**

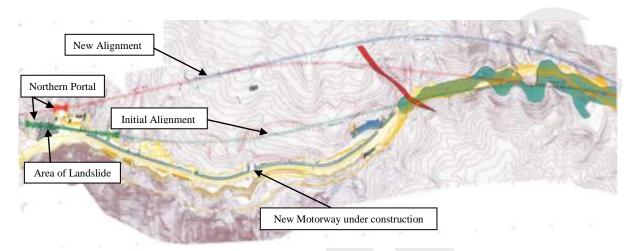
It was because of this instance that the geotechnical engineer in charge requested for another 8 boreholes to be executed along the realigned section of the route, which reportedly confirmed the findings of the original boreholes. On the basis of these findings, the engineer proceeded with his assessment of the geotechnical parameters of the ground and also the design of the temporary support to be applied during the NATM excavation.

Fig.1: Layout of the original and new tunnel alignments following the landslide in the adjacent motorway

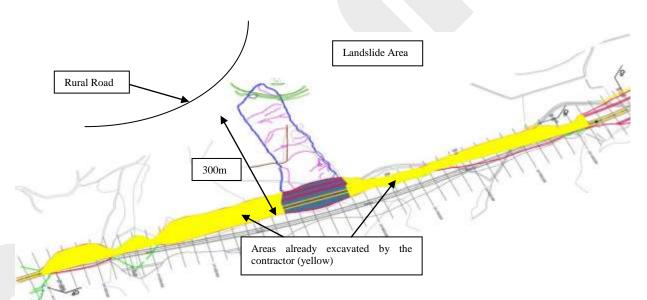
Whereas the excavation work was still in progress, a landslide took place encompassing several parts of the hill side within the area bordered by the length of the earth cut and the some 300m upwards positioned rural road. Besides from moving several meters downhill, the hill side was also vertically settled between 1.5m to 2.0m giving rise to the manifestation of a transitional crack running along the border of the rural road, measuring some 2m in width and 3m in depth.

Fig. 1: Layout of the area of the works
