**MACHINERY BREAKDOWN LOSS
FOR
COOLING TOWERS**

A. SARKAR

THE NEW INDIA ASSURANCE. CO. LTD., INDIA

CASE STUDY – COOLING TOWER

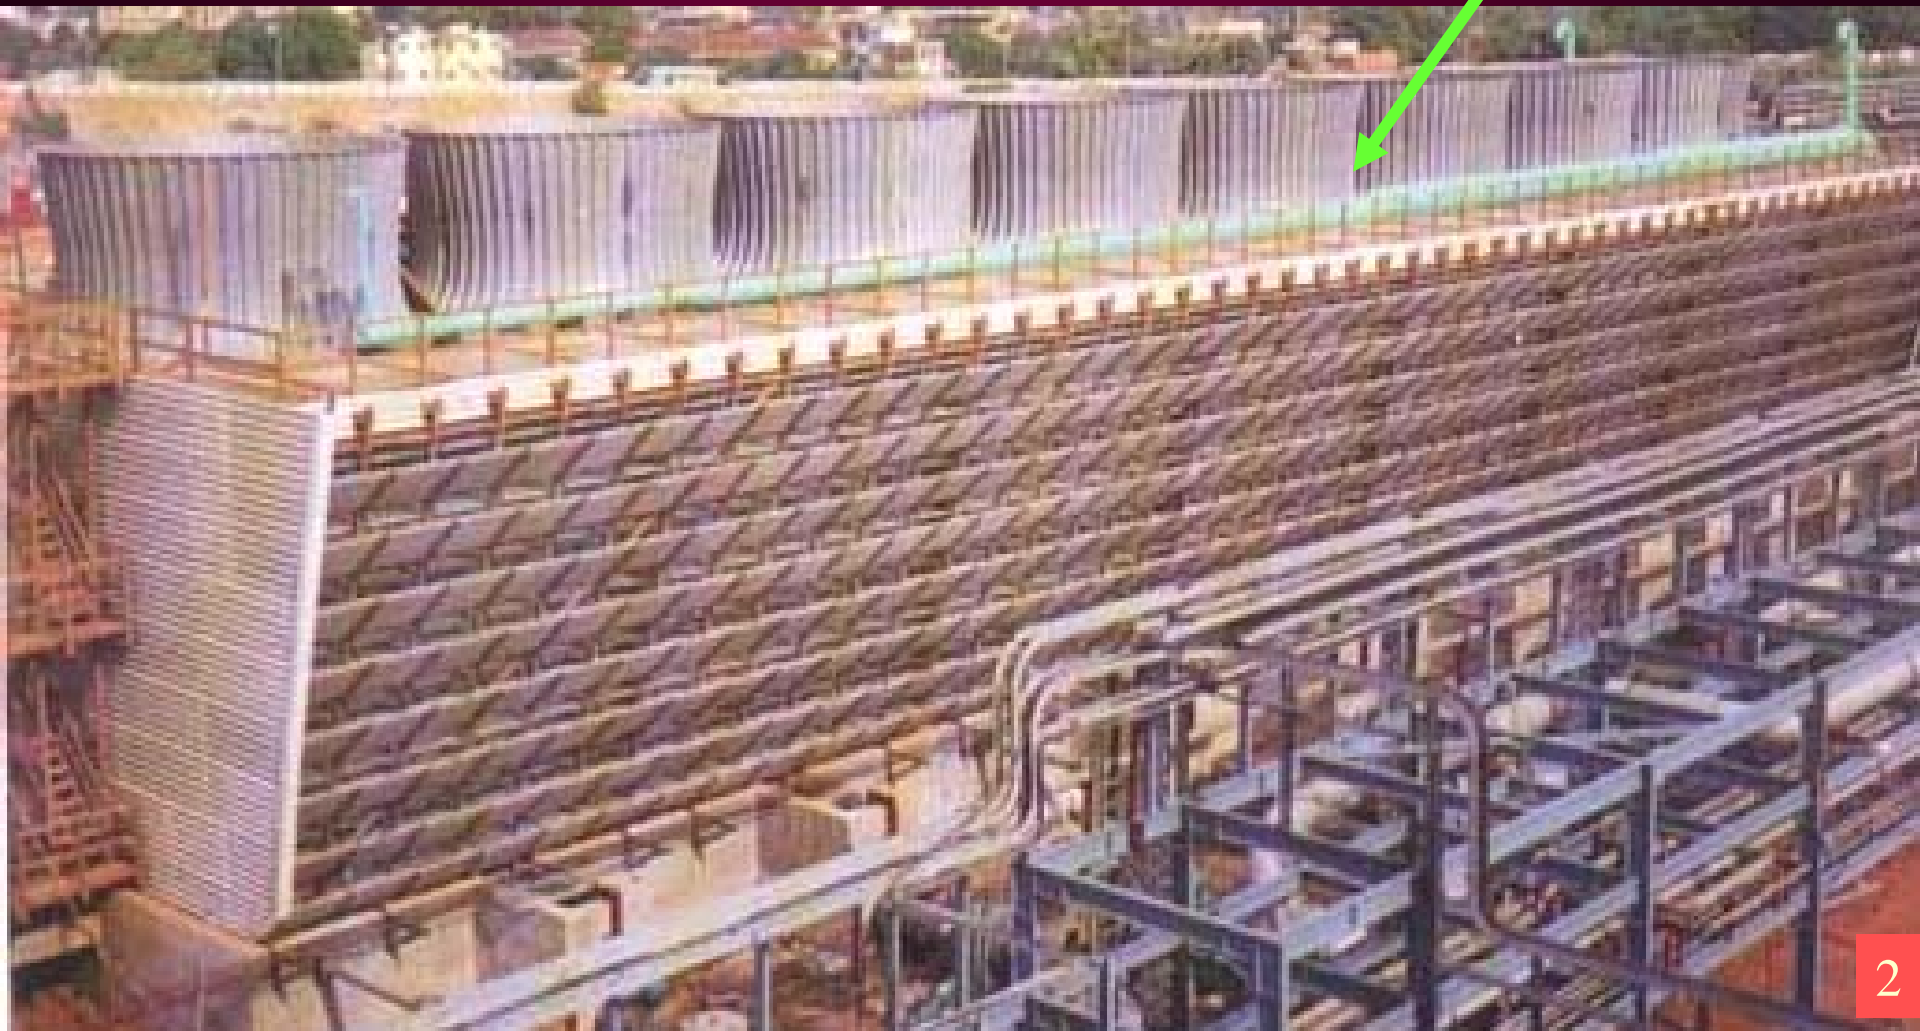
Distributor

- ✓ The field operator noticed heavy sound emerging from the Cooling Tower. Immediately he noticed gushing of water from the Riser bottom.
- ✓ Before the operator could intervene the riser and distributor along with complete wooden structure on front side collapsed. It also flooded nearby area due to heavy water coming out of the damaged riser bottom.
- ✓ Immediately after the incident the water return to the cooling tower was cut off **and emergency shutdown was taken for the plant.**
