# **RALCO HYDROELECTRIC PROJECT CHILE**

## **Damage to upstream cofferdam**

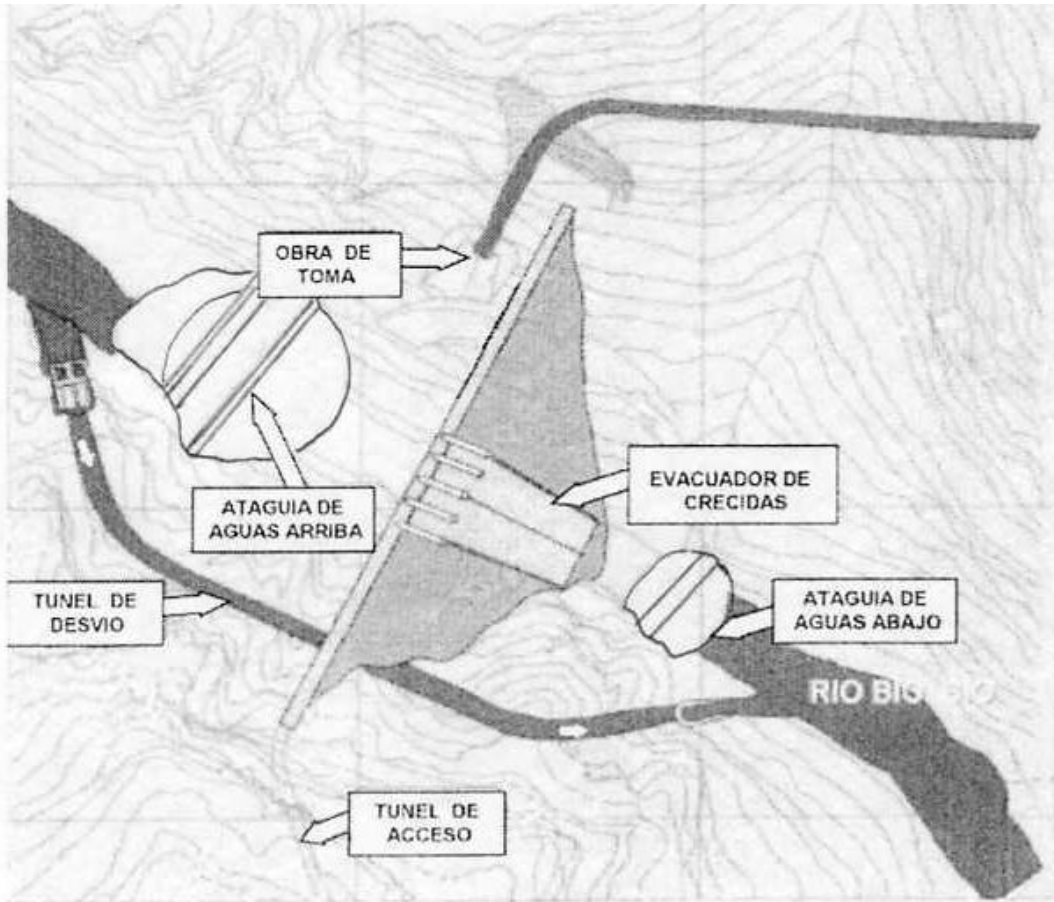
Figure No. 2  
Location of main works

- dam 155 m height
- crest length 350 m
- cavern works and generation units on left bank
- total capacity of 570 MW
- 13.5 m diameter diversion tunnel on right river bank
- Two cofferdams protect Main Dam construction area:
  - upstream 45 m high, crest height 635 m i.e
  - down stream height 605 m

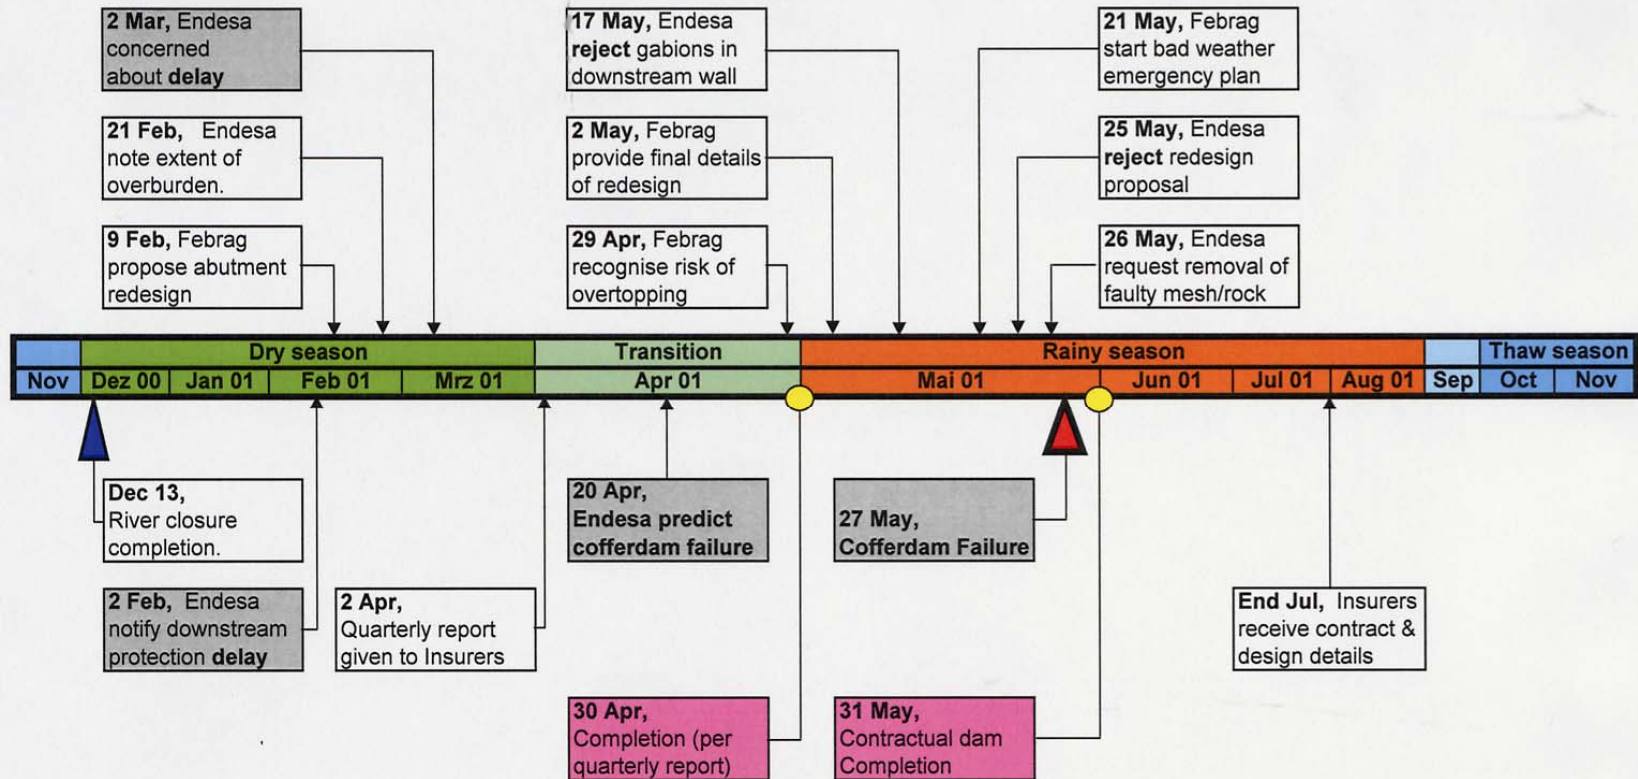
TIMELINE OF CRITICAL EVENTS AND SIGNIFICANT CORRESPONDENCE BETWEEN RIVER CLOSURE AND DATE OF LOSS.
