## IMIA Working Group Paper [WGP 114 (19)]

IMIA Annual Conference, Vienna  
October 2019

### Underground Exposures for Hydroelectric Plants

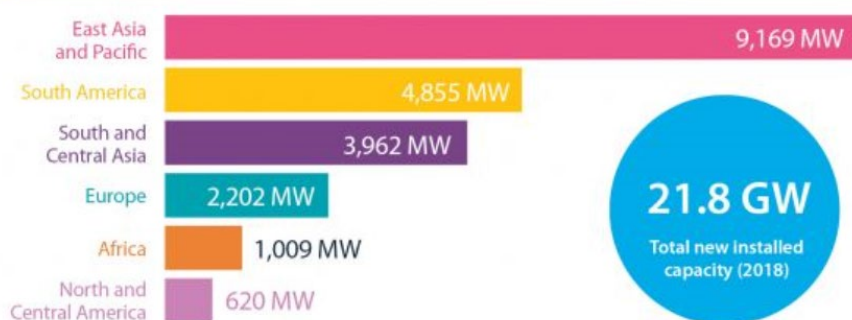
### NEW INSTALLED CAPACITY BY REGION (MW)

The particular areas of development for recent hydro developments have been in East Asia and the Pacific adding 9.2 GW followed by South America (4.9 GW) and South and Central Asia (4.0 GW), all added last year.

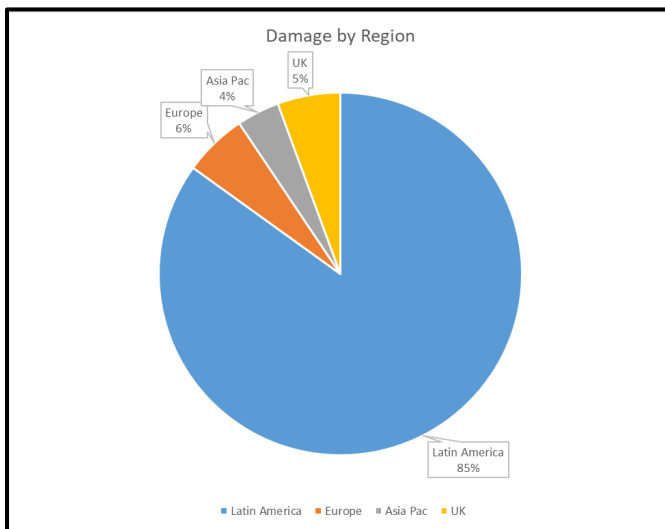
### Damage by Region

The results of this are summarized as follows:

The most significant damaged item (by claim quantum) is tunnel structures in Latin America.
