IMIA – Mass Timber Structures

Introduction

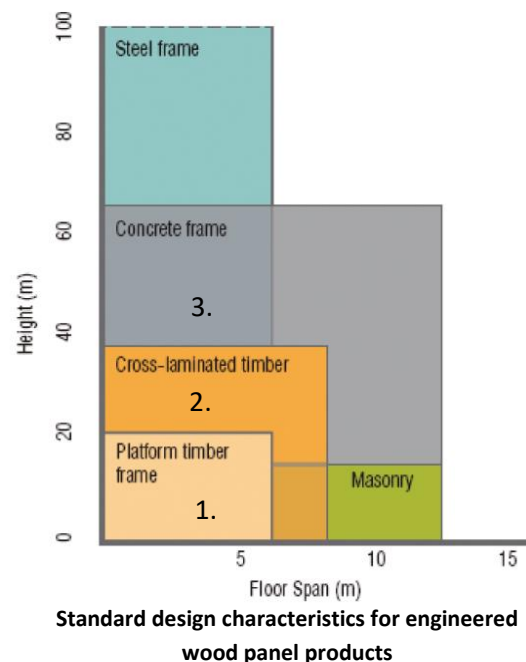
1. **Lightweight timber systems** are divided into Structural Timber Frame buildings and Structural Insulated Panels (SIP). Load-bearing structures use construction timber are is strength graded.
2. **Mass timber systems** include traditional heavy timbers, Cross-Laminated Timber (CLT), Glue-Laminated Timber (GLT), Nail-Laminated Timber (NLT), Dowel-Laminated Timber (DLT), Tongue & Groove (T&G) and Mass Plywood Panels (MPP).
3. **Hybrid constructions** combine wood with different materials and techniques to deliver a wide range of structural solutions (Timber, steel, concrete, and glass) either with one specific hybrid material or multiple configurations to exploit the strength of each.

Lightweight timber systems (18m max)

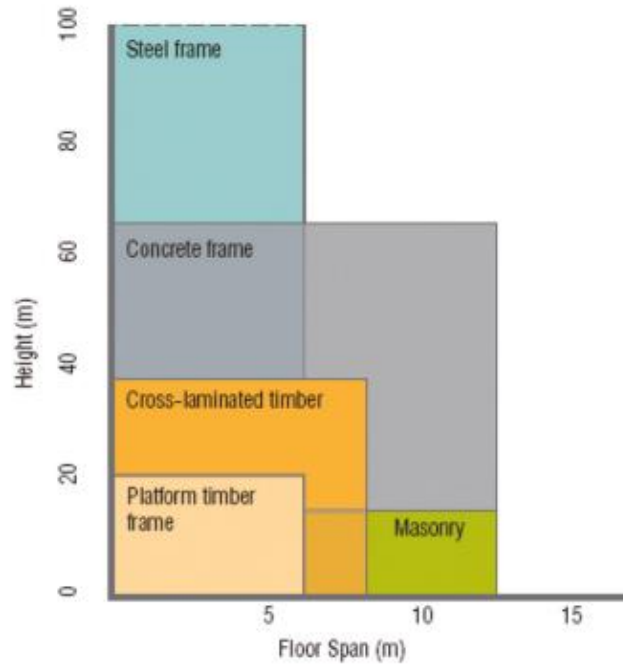
Material	Floor span capability	Height capability
Steel frame	6–7m for composite steel/concrete floors	>100 storeys
Concrete frame	8–12m for solid, prestressed, troughed and ribbed slabs	>20 storeys
Platform timber frame	5–6m for engineered timber joists	7 storeys or 20m
CLT construction	6–8m	12 storeys or more possible*

* Design height limits above 12 storeys are subject to the engineering of the floors-to-walls interface design specific to the project.

High rise multi-storey mass timber structures will have a much greater erection or collapse exposure during a fire. CLT structures of eight storeys have already been constructed in the United Kingdom. Current knowledge supports up to 12 storey designs. The feasibility of building structures up to 30 storeys has been investigated and some projects around the world are beginning to implement at this scale.
