## DETAILS OF INTERESTING CLAIM

No: DOIC 48

Crack on Yankee dryer

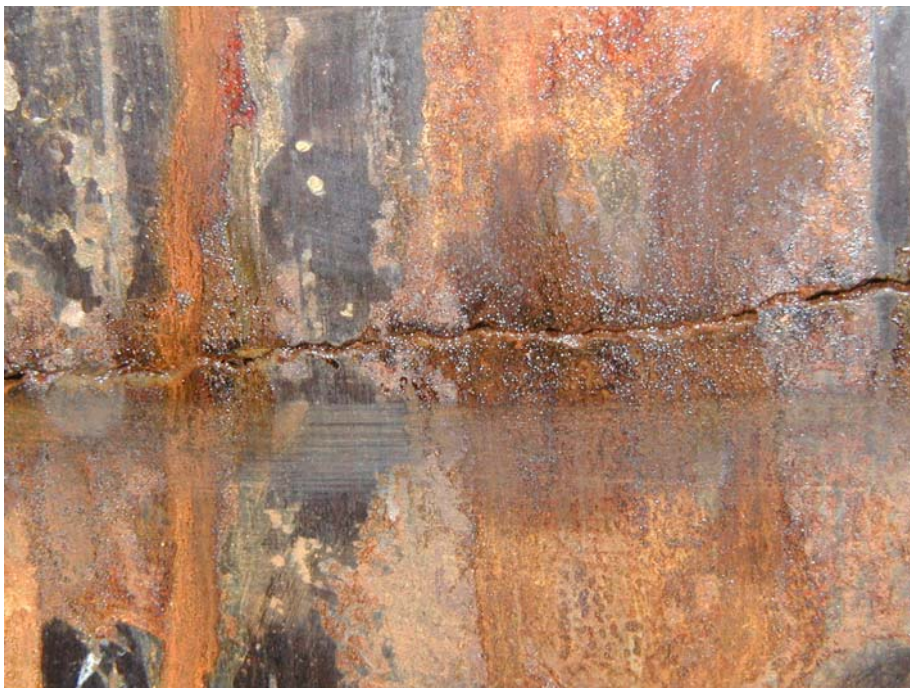
A 1050 mm crack in the surface of the Yankee dryer. At the start up of the paper machine, cold water was sprayed on the surface of the Yankee dryer, which caused thermal tension resulting in the crack.

The Yankee dryer was temporally fixed and replaced after 6 months.
