Damage to a rail bed service machine due to broken frame structure

March 2007, Czechia

Insurance cover: Construction plant and machinery insurance

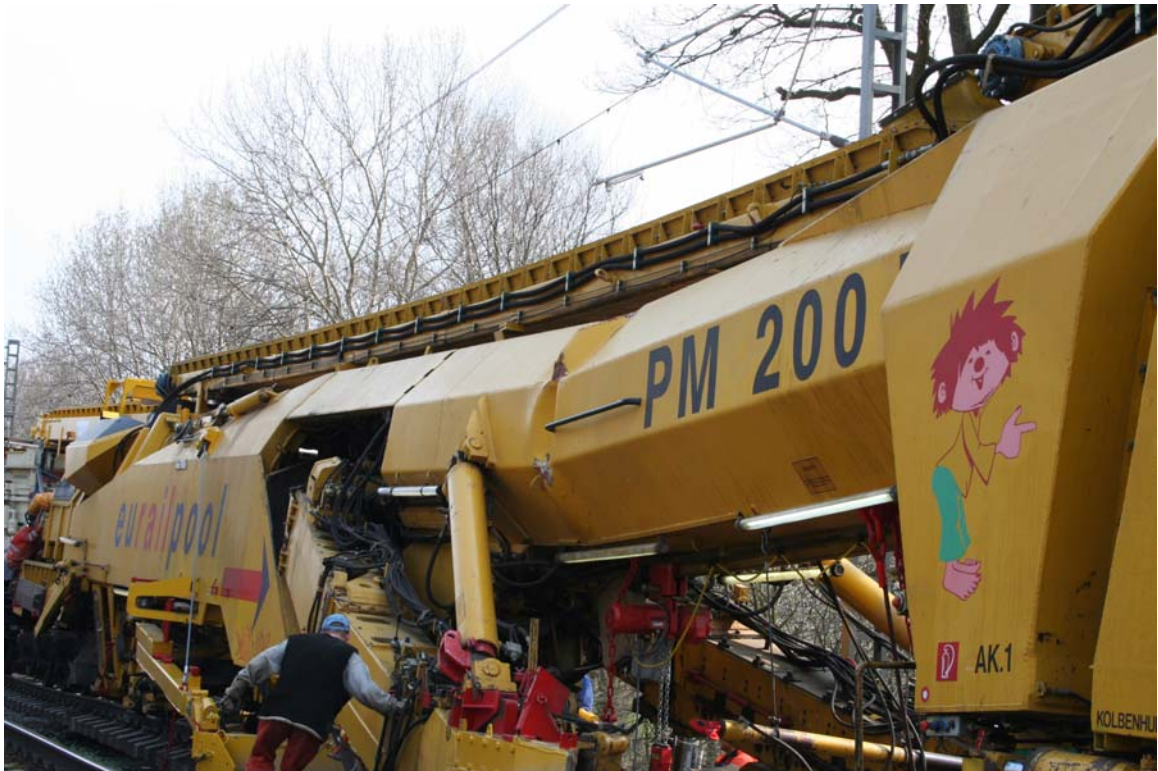
Due to an operational fault the operator let one of the lifted rails fall whilst the arms were moving into the rail bed. This caused the 40 meter frame structure of the machine to break and bend down to the rails.
