DETAILS OF INTERESTING CLAIM

No: DOIC 49

Explosion in Odorous gas collection system

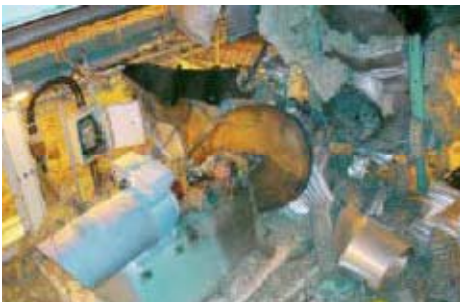
An explosion had taken place in a blower in a malodorous gas collection system in a pulp mill. Possible exceeding of the lower explosion limit of the turpentine gas concentration in the air due to problems in the cooling system.

The reconstruction of the system was done in about two weeks including technical improvements and changes to prevent turpentine vents enter into the weak odorous gas collection system.
