The unit comprised a 15-year-old gas turbine driving an 15 MW electrical generator. It was in cyclical use and had been in operation for a total of approximately 30 000 hours and started around 4 500 times. Three months prior to the failure, an overhaul of the unit had led to various stages of blading and nozzle guide vanes being replaced.

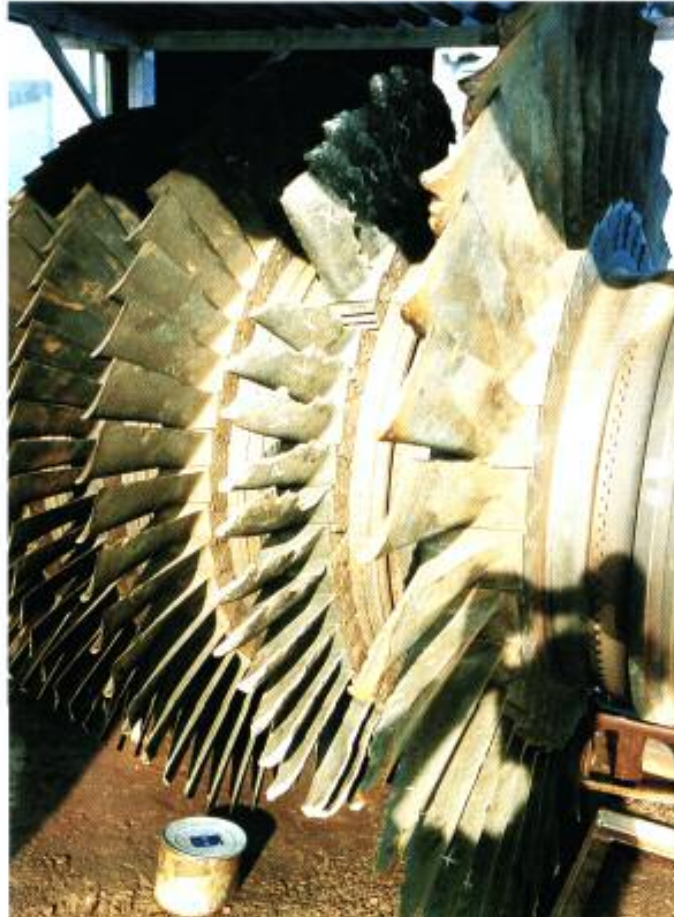
Fig. No. 217
Consequential damage to
rotor blades

During the start-up in question, there was a loud bang and high vibration levels, which tripped the unit. Simultaneously, a fire ignited around the unit's rear bearing, flaring up the outside of the unit and causing severe damage to the casing. On removing the casing, severe damage to the hot gas section of the turbine was discovered.

The failure was caused by a turbine blade moving upstream in its fixing, breaking the restraint device, and eventually coming into contact with static components located upstream. These then snapped off and passed through the turbine, breaking off some of the rotating blades. The ensuing vibration of the unit fractured a lube oilpipe to the rear bearing. This oil then caught fire.

The blade and blade row which caused the failure were not fully inspected or replaced during the previous overhaul. This underlines the need for a full and thorough overhaul procedure to ensure that all necessary actions are taken.

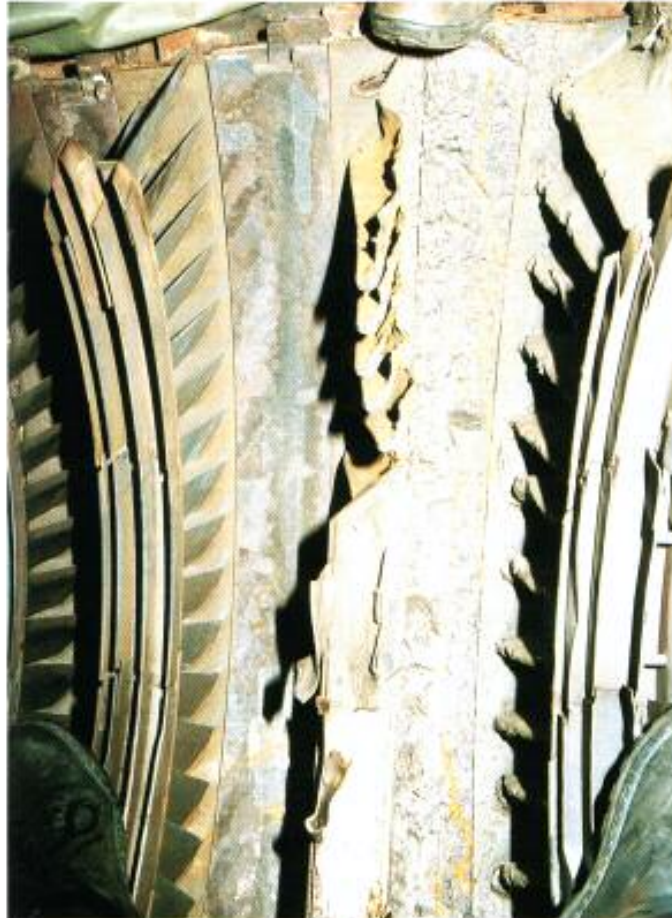
Fig. No. 218
Damage to
static components
