DETAILS OF INTERESTING CLAIM

No: DOIC 43

Steam turbine in paper mill

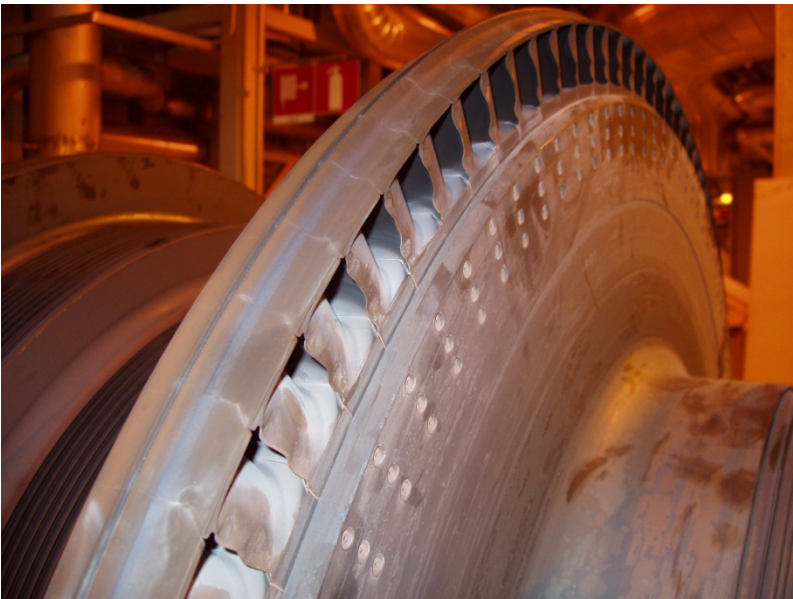
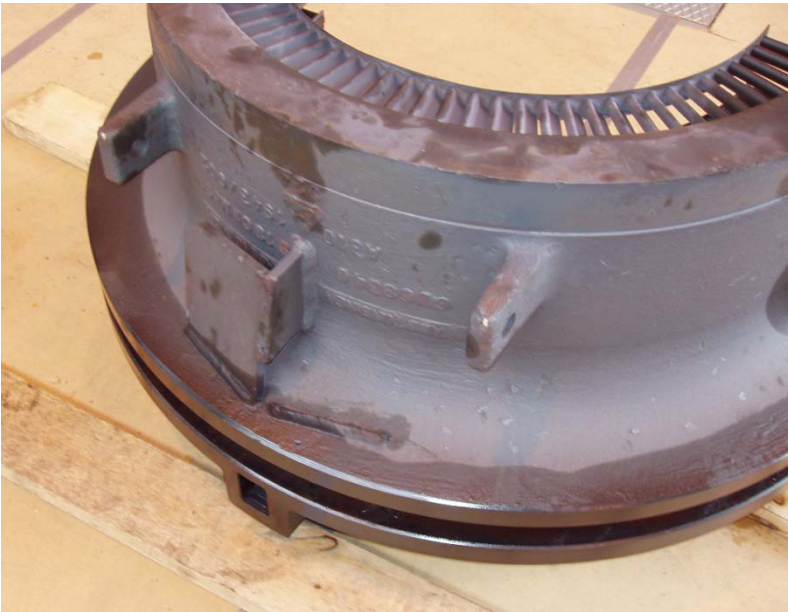
A welded heat protection shield in a steam turbine (approx. 100 MW) at a P&P factory was found broken and had injured the Curtis wheel and both stator and rotor blades. The breaking of the shield was caused by fatigue of the fillet weld.

Both fillet welds of one of the two steam heat protection plates (protecting the inlet spot from overheating that part of the casing) had failed obviously from fatigue cracking resulting from turbulence of the incoming steam. The plate having dimensions of some 15 cm x 15 cm x 1 cm got loose and flew through the machine, causing considerable distortions to the first rows of blades but no direct blade breakages during the event.

The damage and also the cause of the internal impacts on the components were directly seen at the dismantling.

The fact that several blades now were cracked at the base and had risen up somewhat but not broken apart spared the machine from a catastrophic damage.

An in-service program including endoscope at the intermediate overhauls has been implemented. A more sensitive vibration monitoring system has been installed and the vibration level set as a protection parameter and not only as a warning parameter.
