DETAILS OF INTERESTING CLAIM

Fordrinier paper machine consisting of (35) cast iron steam rolls 36" x 84" approx 3/4 " thick circa 1920.

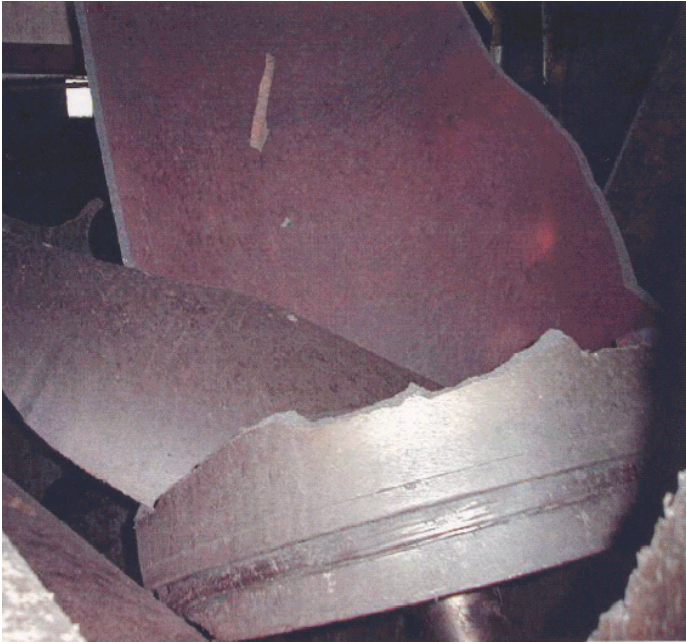
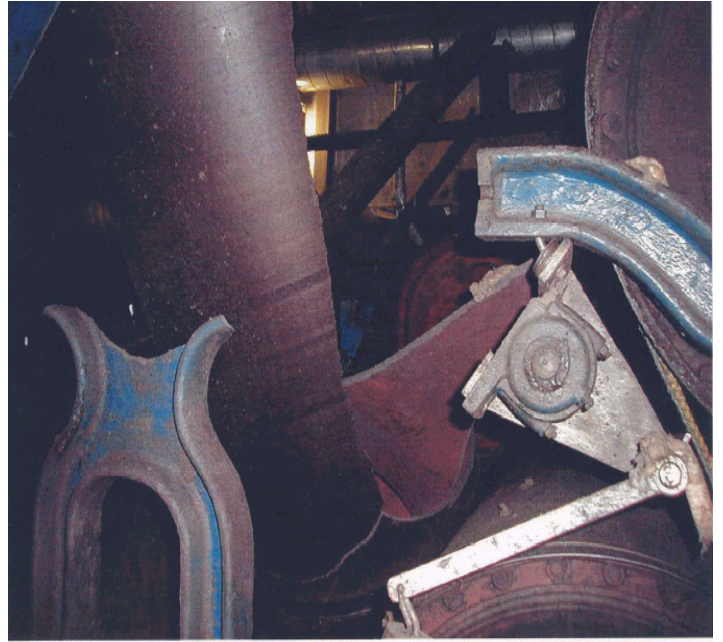
Explosion of steam roll

During the production process a small hole appeared with recurring accuracy on the surface of the paper. It was suspected that a pin hole had developed in one of the rolls. The Chief Engineer decided to run the machine in a test mode to detect which roll was affected and where the pin hole might be. Without the introduction of paper being passed over the rolls to absorb the heat the pressure soon built up to 50 psi from a normal attainable working pressure of 25 psi. The Safety Valve was set at 50 psi. The roll violently exploded. Fortunately no one was injured, however the paper machine was wrecked.

- It was determined that when this vessel was manufactured it was not concentric and had weights installed to balance it. The casting revealed two thicknesses of metal however while this did not cause the accident it did reveal serious misgivings on the structure of the vessel.

- The roll should have been isolated and subjected to a hydrostatic test (not steam) to detect where it was leaking and more than likely would have failed, however the catastrophic damage would have been avoided and there would be no temporary lay offs at the plant.
- The policy contained a testing exclusion but it was determined that what the insured was doing was not an official test but the machine was in fact being operated under normal pressures.
- How often do we inspect a boiler or a pressure vessel while in the operational mode and assuming that since it is working below a safety valve setting it is being safely operated?
- The vessels had inspection ports, the inspector verbally suggested they look inside a random selection during the next outage. Given the age of the machine however, all the vessels should be operated at a reduced MAWP.
