Slide No. 140
 Micro power plant destroyed
 by avalanche

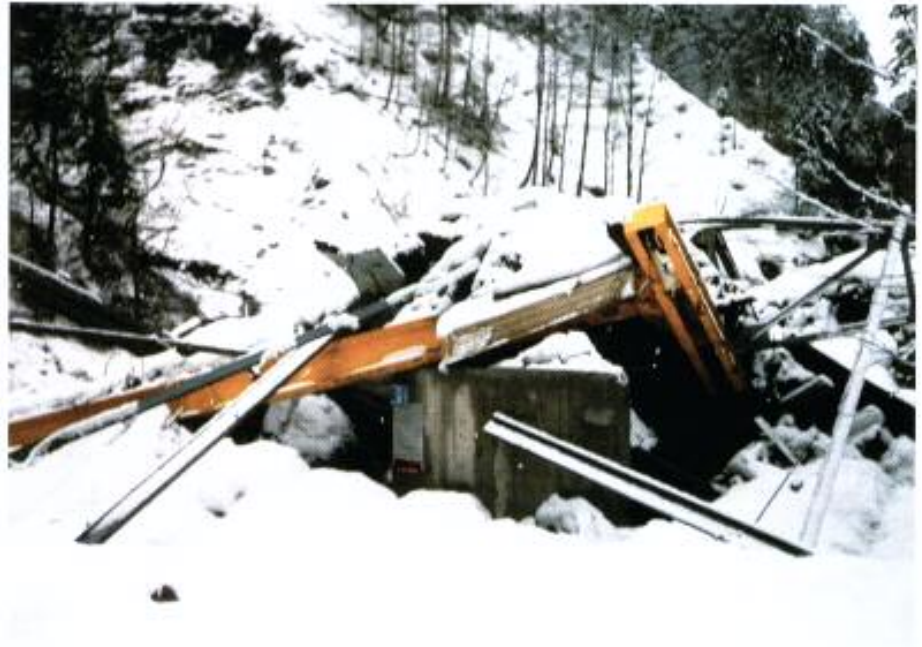
Amount of Loss	CHF 780,000
Cause	A mudslide hit and covered a power plant, which is situated 830 m above sea level, with 1 m of dirt.
Short Description	The building (16 m / 9 m, reinforced concrete) housing the power plant with two Francis Turbines (340 kw and 740 kw), was partially destroyed, allowing a mixture of soil, stones and snow to enter and damage generators, switchboard, turbines etc.
Comments	The reconstruction of the two turbines caused a delay of six months. The site was approved for construction by the authorities and at first glance did not appear to be very exposed to mudslides or to avalanches since it is situated only 830 m above sea level and seemed to be well protected by the wooded mountain slopes.
Conclusion and Loss Prevention	Even if the site lies within an area approved by the authorities for construction, principals should carry out their own safety checks with respect to surrounding exposures.

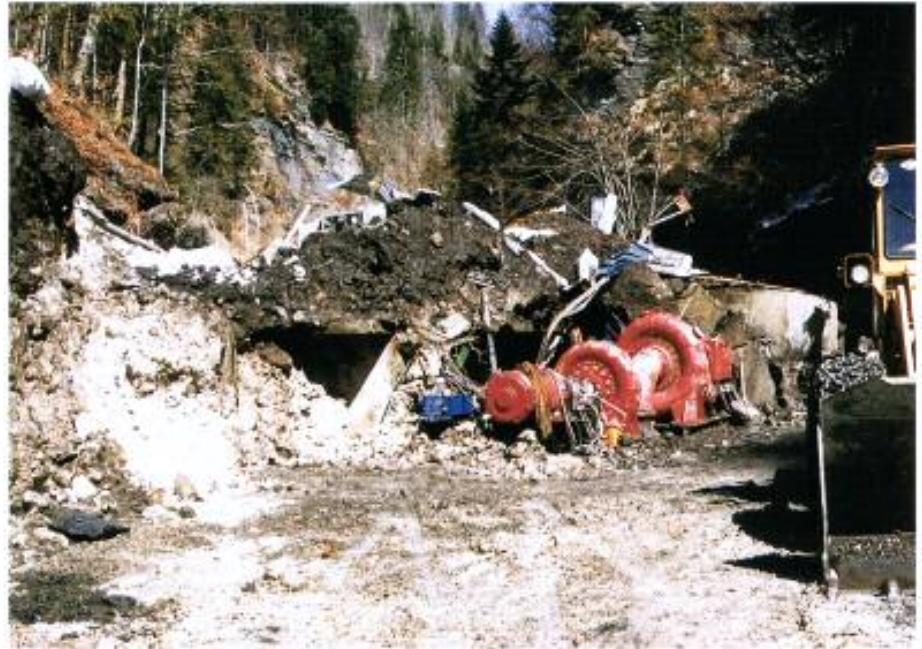
Slide No. 141
View of the site after
removal of debris

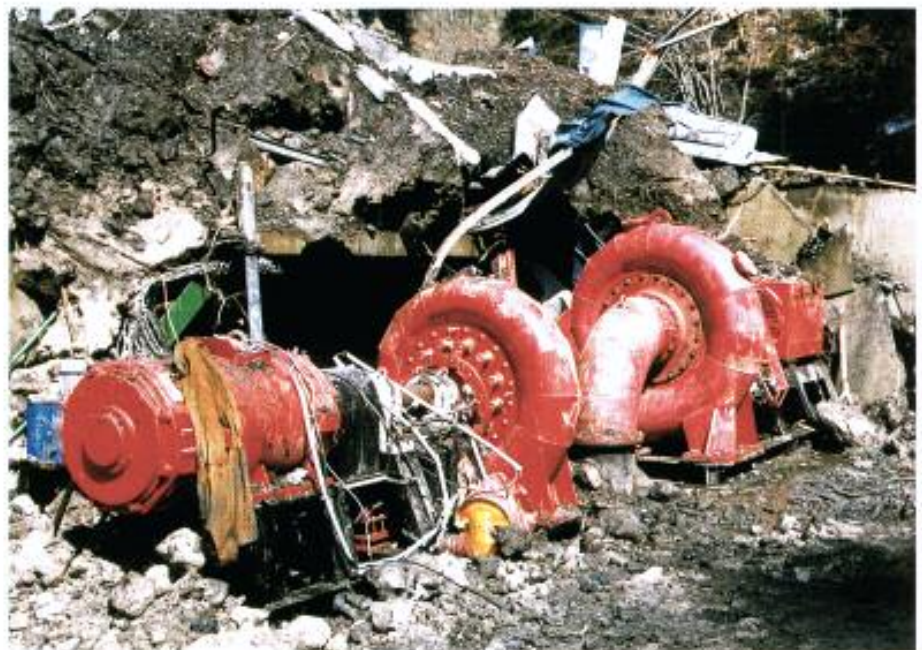
Slide No. 142
A close-up of the above
site gives a better view of
damage to the installations.
