Engineering Insurance

## Claims Review

**Erection All Risks**

Oil Storage Tanks

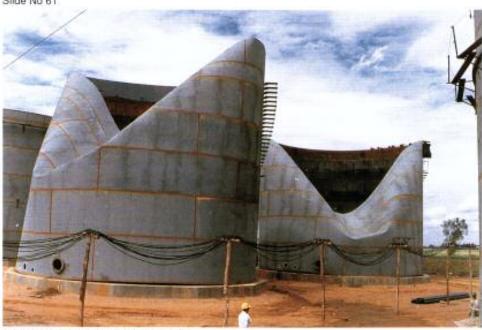
Slide No 61

Two damaged items out of 14 fuel tanks

Windstorm

Two out of 14 tanks collapsed due to strong winds

Comments and loss prevention The collapse of tanks during their construction is an event loss prevention which can often be avoided by proper prevention measures. In this case, the loss could have been reduced to 50 % if construction had been programmed in such a way that only one tank at a time reached the critical height.

Furthermore, during known periods of possible high winds, the height of the walls should not exceed 3 rings.

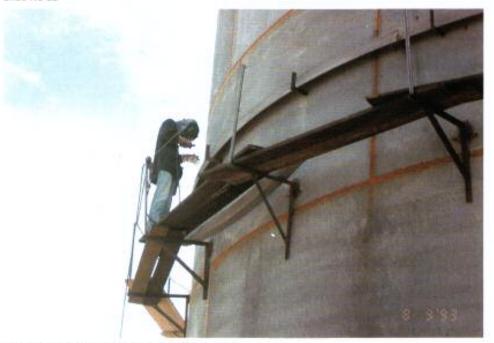
Slide No 62

Fixing of wind girder along the fourth ring tank shell

Finally, other measures can prevent collapses, such as the fixing of wind girders (slide No 62) and quick erection of roof beams (slide No 63).

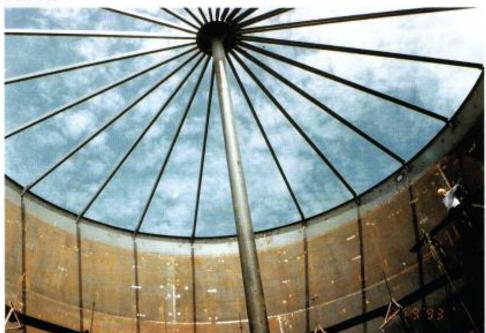
Slide No 63

Tanks with an arrangement of roof beams between the upper rim and centre post were unaffected.
